CM100 WATERPROOFING - HIGH BUILD SYSTEM

# SYSTEM DETAIL

INSULATED PLAZA DECK WITH PAVERS

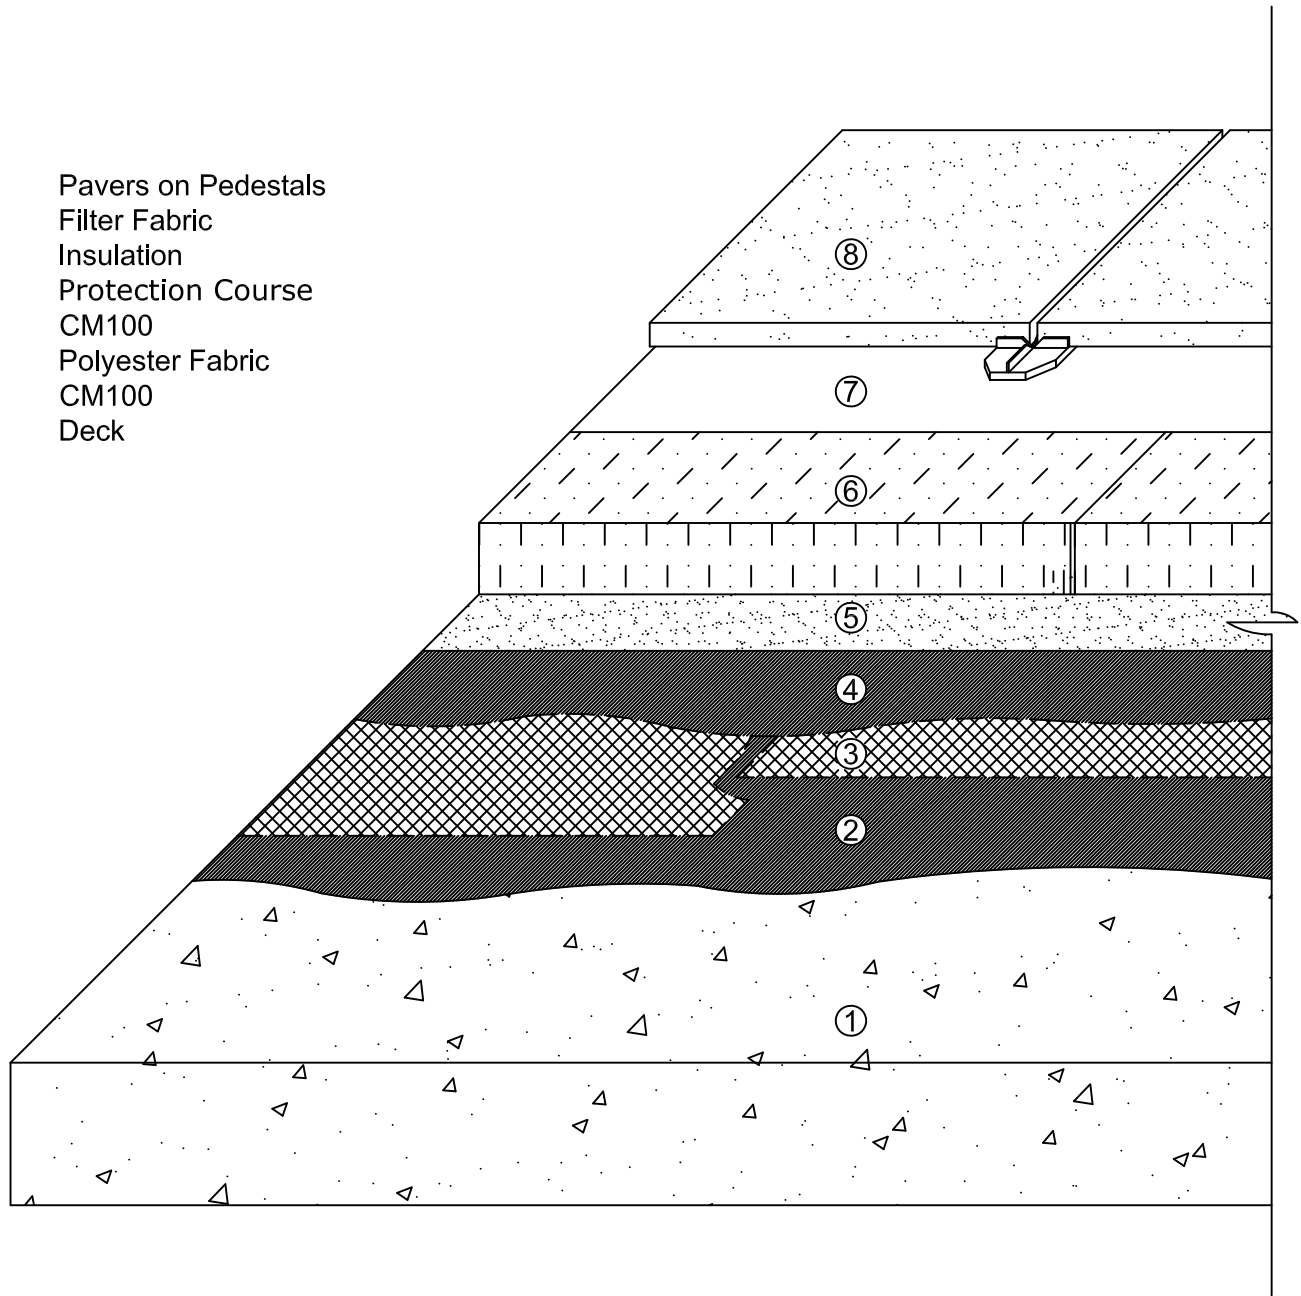
- 8. Pavers on Pedestals
- 7. Filter Fabric
- 6. Insulation
- 5. Protection Course
- 6. CM100
- 3. Polyester Fabric
- 2. CM100
- 1. Deck

- 1. Detail showing CM100, a two ply reinforced, cold-applied, fast curing waterproofing membrane system incorporating insulation and pavers.
